SERVICE BULLETIN BOOK

1990

WMS GAMES

SERVICE BULLETINS

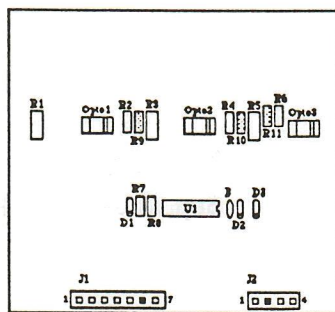
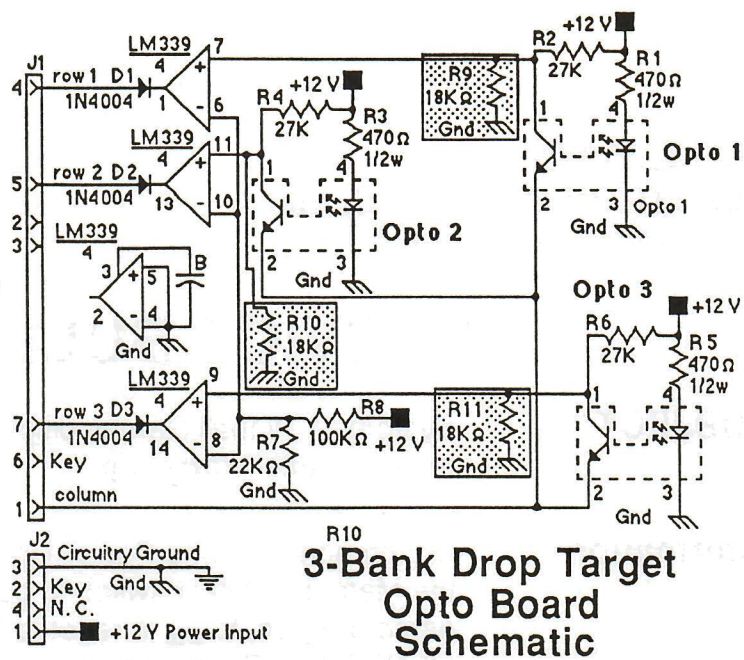
Figure 1. 3-Bank Drop Target Opto Board

SUBJECT: Solution of possible problems with 3-Bank Drop Target Opto Boards. Problems may include (a) unexpected TILTS or (b) unearned CREDITS.

1. Make sure that the plugs on connectors J1 and J2 of the Opto Board are making proper electrical connections.
2. Check to verify that each of the three 1N4004 diodes (for noise suppression and blocking) on the 3-Bank Opto Board is functioning properly. (See Figure 1.) The cathodes of these diodes connect to the outputs of IC1 (Pins 1, 13, and 14), and the anodes connect to, respectively, Pins 4, 5, and 7 of J1.

For older Opto Boards (C-11318-1) experiencing the problems mentioned above, these diodes can be added, using the proper technique, as follows:

- (A) Cut the circuit board trace between IC pin 1 and J1-4. Connect (solder) the anode of a 1N4004 diode to the trace connected to J1-4. Connect (solder) the cathode of that 1N4004 diode to the trace connected to IC pin 1.
- (B) Cut the circuit board trace between IC pin 13 and J1-5. Connect (solder) the anode of a 1N4004 diode to the trace connected to J1-5. Connect (solder) the cathode of that 1N4004 diode to the trace connected to IC pin 13.
- (C) Cut the circuit board trace between IC pin 14 and J1-7. Connect (solder) the anode of a 1N4004 diode to the trace connected to J1-7. Connect (solder) the cathode of that 1N4004 diode to the trace connected to IC pin 14.

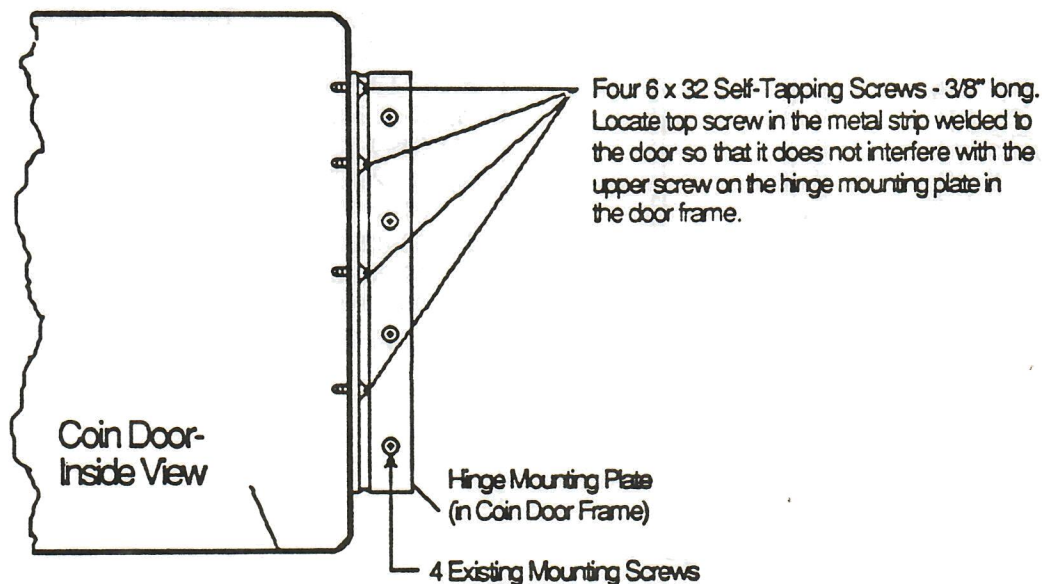
Figure 1. Inner View of Coin Door Showing Installation.

SUBJECT: Solution of possible problems with welded Hinge Mounting Plate of the Coin Door.

1. Open the Coin Door fully to permit access to welded Hinge Mounting Plate of the Coin Door.
2. Drill four holes in the approximate locations shown in Figure 1, using a #32 (0.116 in.) drill bit. Note that the upper hole must be located so that the screw to be installed does NOT interfere with the top mounting screw on the door frame Hinge Mounting Plate.
3. Install four 6-32 Self-Tapping screws - 3/8" long in the drilled holes. Tighten them securely to provide maximum assurance against separation of the weld on the Hinge Mounting Plate.

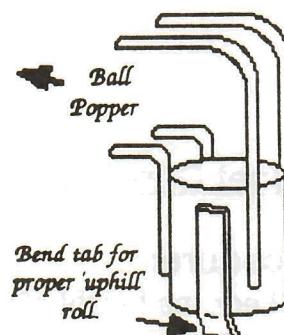
Ball Popper Wire Ramp Exit Tube Adjustment

The first adjustment affects the ball direction, as it exits the tube at the end of the Ball Popper Wire Ramp. The second adjustment affects the ball location when 'frozen' by the magnet. The third adjustment affects the magnet core height.

1. Check the direction and distance of ball movement as it exits the Ball Popper Wire Ramp tube. As it drops out of the tube, the tab at the bottom of the tube should send the ball rolling 'uphill' (upward on the playfield) approximately 1 inch, before rolling down the ball guide into the "Deep Freeze" Magnet region, near the Upper Right Flipper.
2. Adjust the tab at the lower end of the Ramp tube to obtain the proper 'uphill' roll. Be careful of the 'uphill' roll distance because too long an 'uphill' roll can cause the ball to gain too much momentum and roll completely through the magnet area too fast for the magnet to 'freeze' (hold) it. Also, be careful of the direction of the roll. The tab should direct the ball slightly toward the ball guide to ensure that the ball will roll through the magnet region, rather than possibly bouncing away from the magnet region.

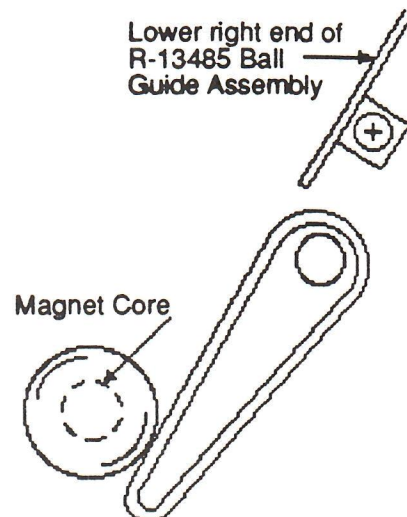
Ball resting on Upper Right Flipper rubber, during Magnet 'Freeze'

1. Check the ball movement as the magnet 'freezes' (holds) it. Ideally, the ball will be rubbing on the red flipper rubber, during the 'freeze'. This dampens the magnetic oscillations much faster and allows a well-aligned shot up the left Upper Plastic Ramp.
2. Adjust the Upper Right Flipper paddle position, if possible, to allow the ball to rest on the red flipper rubber, while the magnet is holding it.
3. Be careful during this adjustment to **avoid** making the "loop" shot around the ball guide at the top of the playfield end in an 'outhole' drain (up the left side of the ball guide, around the upper rim, and down the right side of the ball guide, past the flipper paddle, and down between both lower flippers into the outhole). The Upper Right Flipper paddle should send the ball onto the lower right flipper, when properly adjusted.

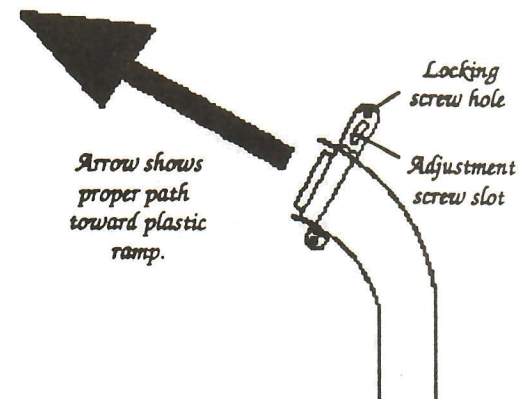
Shooter Lane Exit Path Adjustment

Information: As the ball exits the shooter lane, it should proceed across the playfield and go up the plastic ramp (as shown by the dark arrow). Adjustment of the shooter lane ball guide may be necessary to obtain this ramp shot.

1. Check the ball trajectory (path) from the shooter lane ball guide toward the plastic ramp. The ball should move smoothly up the ramp entrance.
2. If necessary, loosen the ball guide screw in the ball guide slot, and reposition the ramp to obtain the proper ramp entry.
3. To maintain the ball guide position, install another screw in the Locking Screw hole.

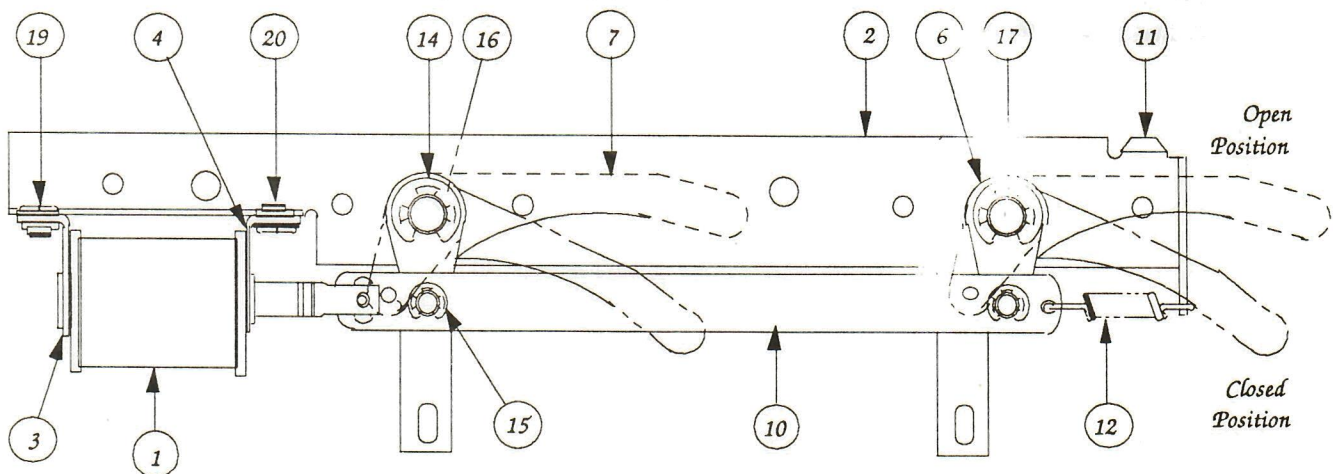
Upper Diverter Assembly
p/n C-13489 , Rev. C

SUBJECT: ROLLERGAMES Upper Diverter Assembly Improvements

Information: Improvements to the Upper Diverter Assembly, p/n C-13489, include (1) a coil change (replace the AE-23-800 coil with one marked AE-26-1200); (2) a Solenoid Bracket Assembly, p/n B-13488, change; and (3) a change to the assembly comprising the coil plunger, drive link, and spring.

It is suggested that these changes can occur in the order listed in the preceding paragraph; that is, coil replacement should be first, followed by replacing the Solenoid Bracket Assembly. If necessary, the more complex change of the coil plunger, drive link, and spring should resolve all associated problems with the Upper Diverter Assembly.

- A. Unsolder the wires connected to the Coil, noting each wire's coil terminal.
- B. Remove the solenoid bracket Mounting Screws (19), retaining them for reassembly.
- C. Remove the AE-23-800 Coil (1), and replace it with an AE-26-1200 Coil.
- D. Replace the Solenoid Bracket Assembly, p/n B-13488, (3) with a new 'revision A' Assembly. (The revision A Solenoid Bracket Assembly has a slightly shorter solenoid stop than the original assembly.)
- E. Mount the Coil (1) and Solenoid Bracket Assembly (3), as they were on the original unit; install and tighten the bracket Mounting Screws (19), using Loc-Tite.
- F. Solder the wires to the new Coil, connecting them to the proper terminals (noted in step A).

- C. Replace all of the old Drive Link parts (coil plunger, springs, etc.) with the new Link-Plunger-Spring Assembly (10), p/n B-13843, sliding the plunger into the coil and inserting the post of each Arm Assembly (7) into the proper hole of the new Link-Plunger-Spring Assembly.
- D. Attach an "E" Ring on each Arm Assembly post to reassemble the Link-Plunger-Spring Assembly. Slip the loop of the Spring into the hole of the Diverter bracket, where the old spring was removed.
- E. Move the updated Diverter Assembly back and forth several times to verify that it is moving freely, without binding. If necessary, apply a small amount of Williams' Drop Target Grease (or similar lubricant) to the rotating posts on each Arm Assembly.
