SERVICE BULLETIN BOOK

1990

WMS GAMES

SERVICE BULLETINS

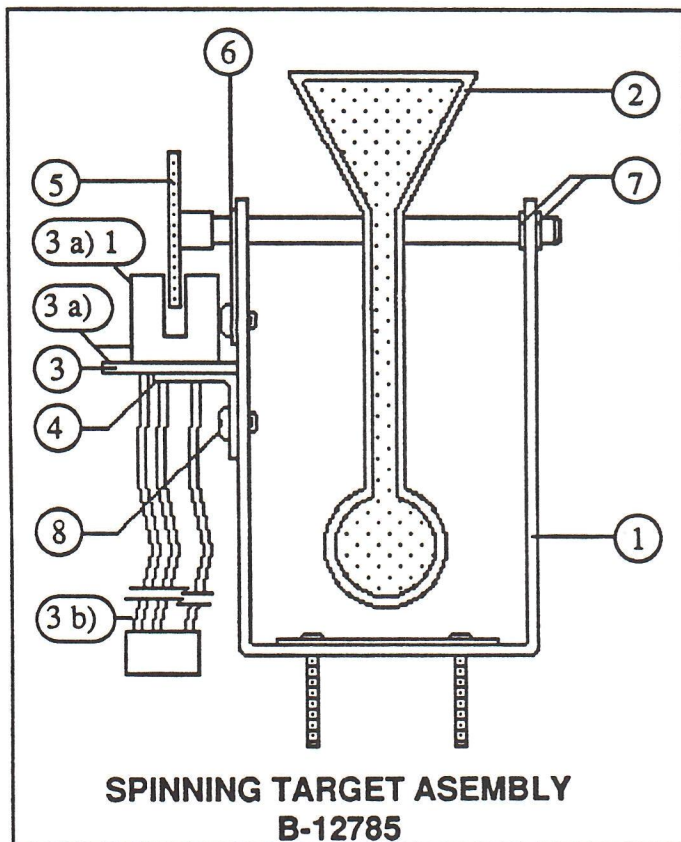
SPINNING TARGET ASSEMBLY B-12785

SUBJECT: Corrected Parts List and Illustration for **POLICE FORCE** Spinning Target Assembly

Information: Please correct the Parts List and Illustration, on page 58 of your game manual, for the Spinning Target Assembly, p/n B-12785. (The callouts in the game manual are incorrect. We are also adding the part number for the Optotransistor, mounted on the Opto Switch & Cable Assembly.)
